LAKE ROBERT ROOKE DAM

PHASE I INSPECTION REPORT NATIONAL DAM SAFETY PROGRAM

REPT. NO. DAEN/NAP - 53842 / NJ00262 - 81/08

MARCH 1981

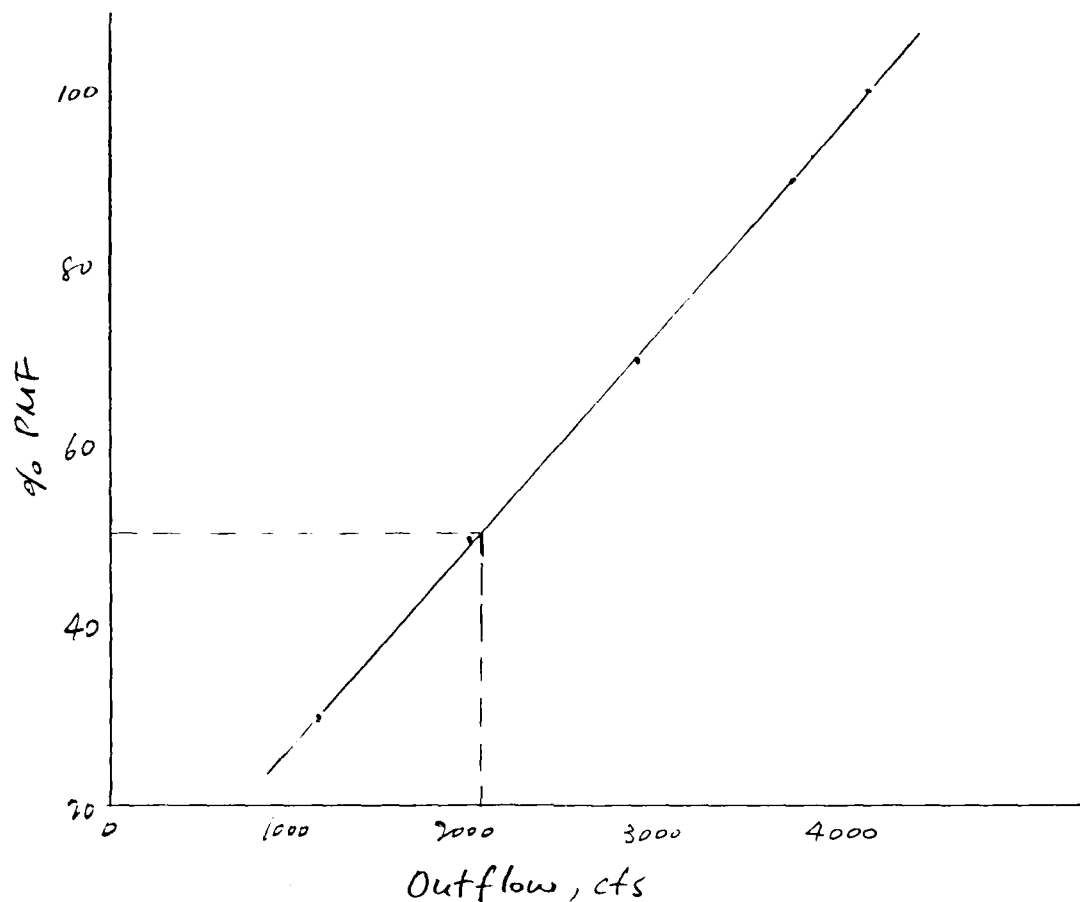
The combined drop inlet and emergency spillway capacity as determined by the Corps of Engineers Screening criteria is inadequate. We estimate the dam can adequately pass only 51% of the PMF.

% PMF vs Outflow indicates
the dam can adequately pass approx. 51% of PMF
at 2093 cfs
